**Further Measures to Preserve Trees and New Measures to Create Greenery
in the Jingu Gaien District Urban Redevelopment Project
(Supplementary Materials)**

Further Measures to Preserve Trees and New Measures to Create Greenery in the Jingu Gaien District Urban Redevelopment Project

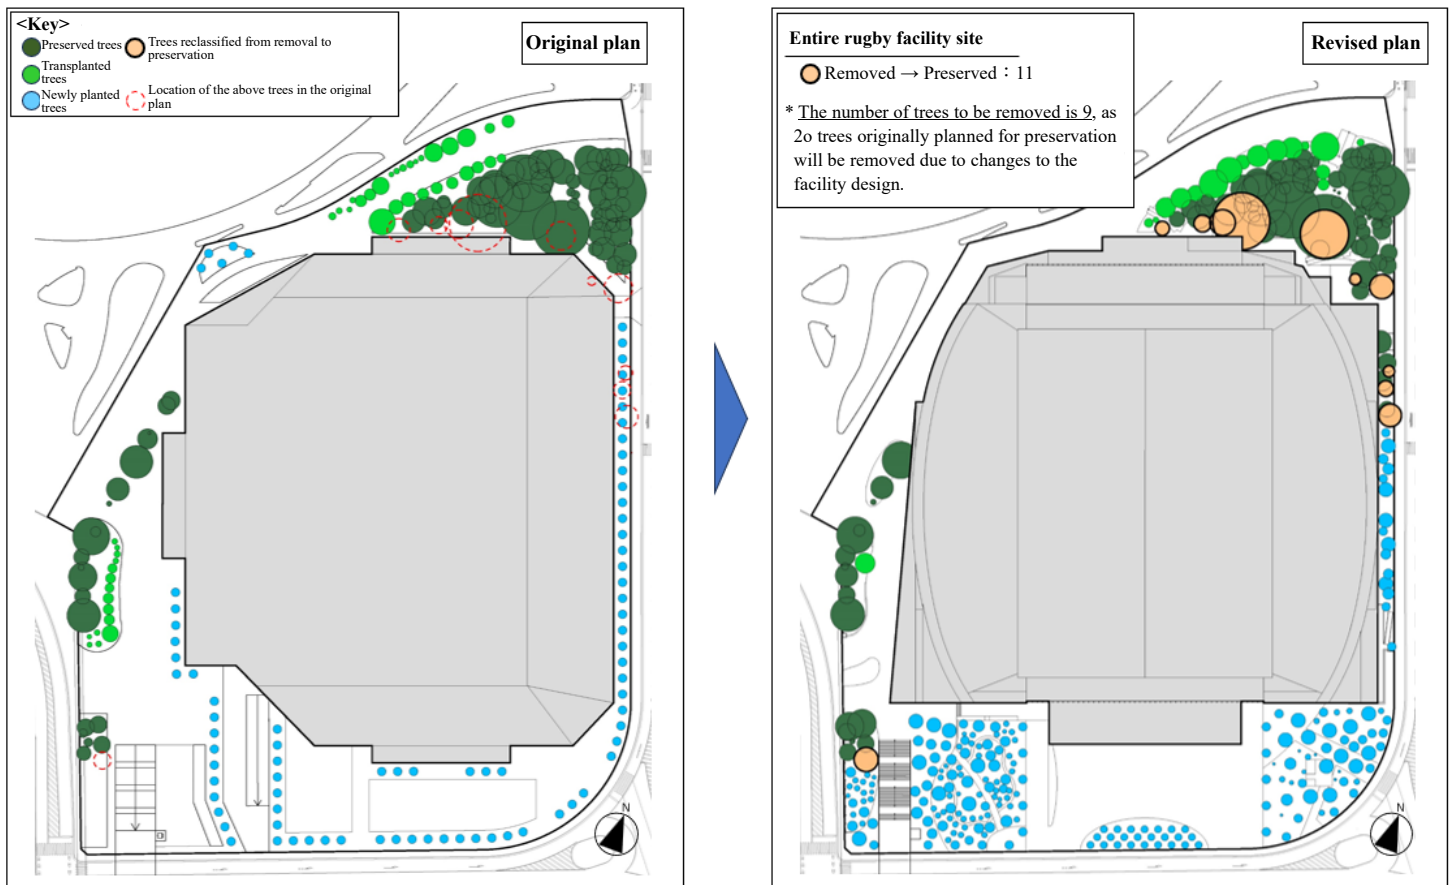
Figure 1 New rugby facility site - Location of reclassified trees and facility design changes

By setting back part of the northern section of the new rugby facility, 9 trees for removal at the Kenkoku Kinen Bunko site will be preserved (Figure 1).

To improve the growing environment for trees around the new rugby facility, the height of the building will be reduced from approximately 55.0 meters in the original plan to around 48.0 meters.

*2 Existing trees shown in the figure for the original plan are based on data from the 2019 tree research, while existing trees shown in the figure for the revised plan are based on data from the 2023 tree research; tree canopy (shown by size of circle) may differ between the figures due to tree growth, etc.

*3 Preserved trees shown in the figure for the revised plan include trees that have been reclassified from transplant to preservation due to the facility design adaptations.

*4 Only trees 3.0 meters or taller are shown.

*5 Specific details on the location of transplanted and newly planted trees are yet to be determined and may be subject to change.

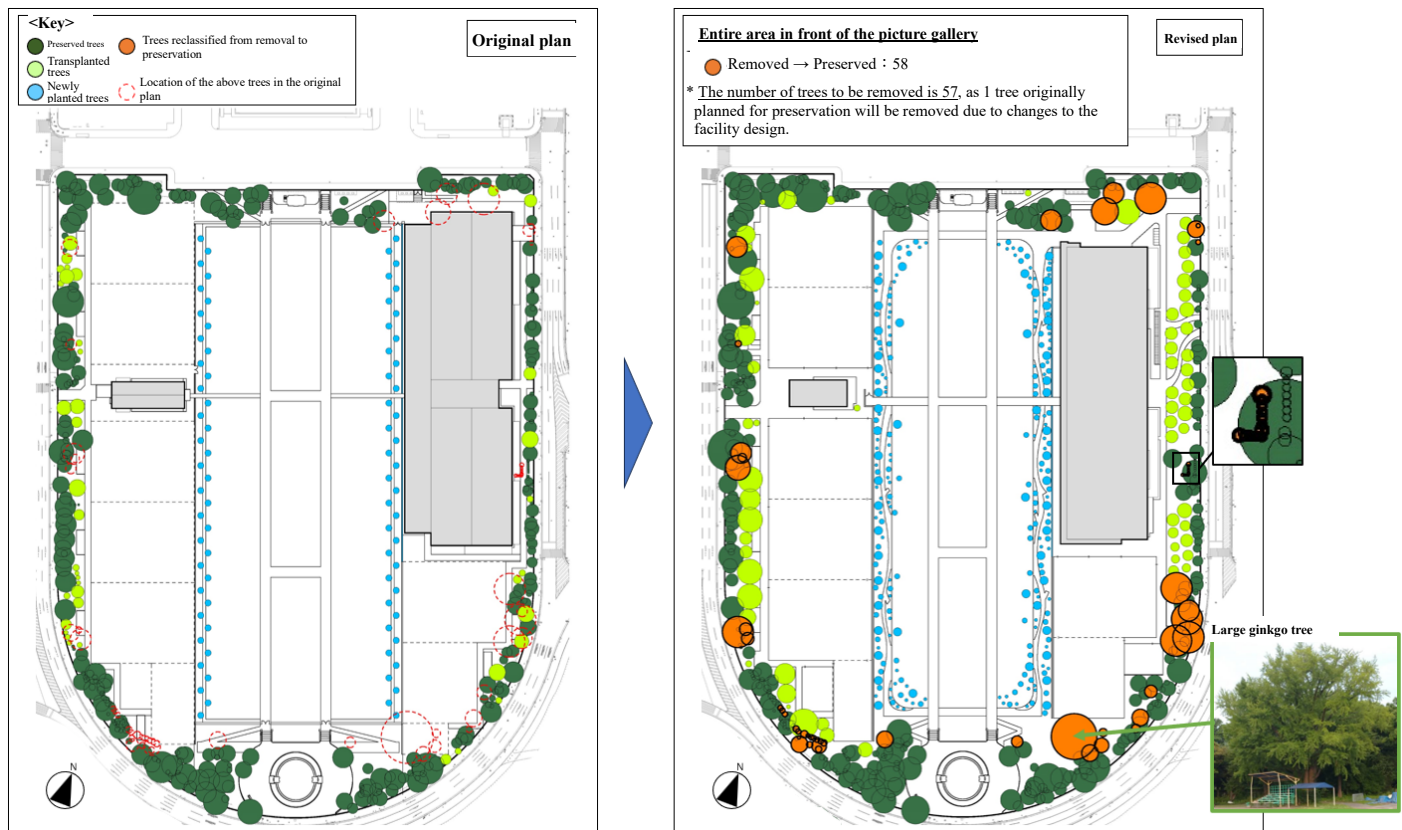
Figure 2 Area in front of the picture gallery - Location of reclassified trees and facility design changes

Due to changes to the layout and a reduction in the scale of buildings and other structures, 55 trees for removal from the road around the gallery will be preserved (Figure 2).

Due to design changes to the Maruike area, 2 trees for removal will be preserved (Figure 2).

- *6 Existing trees shown in the figure for the original plan are based on data from the 2019 tree research, while existing trees shown in the figure for the revised plan are based on data from the 2023 tree research; tree canopy (shown by size of circle) may differ between the figures due to tree growth, etc.
- *7 Preserved trees shown in the figure for the revised plan include trees that have been reclassified from transplant to preservation due to the facility design adaptations.
- *8 Only trees 3.0 meters or taller are shown.
- *9 Specific details on the location of transplanted and newly planted trees are yet to be determined and may be subject to change..

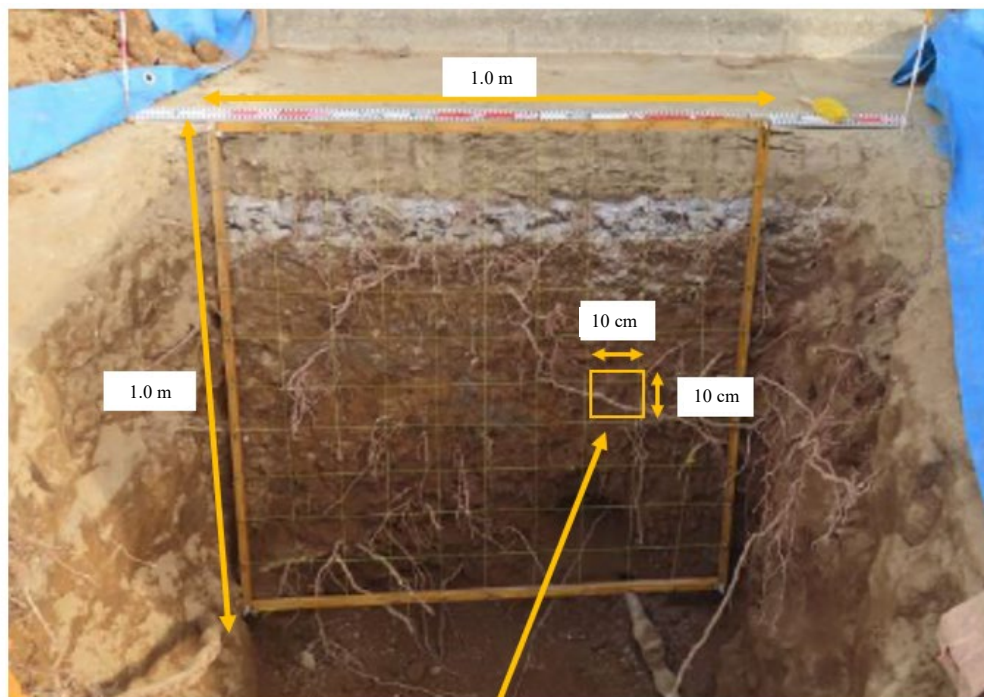
Figure 5: Survey cross section criteria in root system research

The environmental impact assessment report has set the distance from the sidewalk curb on the west side of the rows of ginkgo trees to the underground framework of the new baseball stadium (hereinafter, “the setback width”) as 8.0 meters. It also sets following criteria for determining how to deal with roots: “If root system research results in fewer than four large roots (diameter of at least 30 millimeters) in the surveyed section (1.0 meter x 1.0 meter), the roots may be cut, and if the research finds four or more roots, girdling shall be carried out on the roots. In cases where a tree doctor has judged that there are multiple roots that have an influence on the growth of a tree, then efforts will be made to preserve said tree, including adjustments to facility design, based on the opinion of the tree doctor.” (Figure 5)

- Root distribution checked within each 10 centimeter mesh square of the survey cross section (1.0 meter x 1.0 meter)
- The criteria for making judgements in the environmental impact assessment report are as follows.
 - Fewer than four roots with a diameter of at least 30 millimeters: Roots will be sharply cut off
 - Four or more roots with a diameter of at least 30 millimeters: Roots will be girdled
 - If a tree doctor judges that there are multiple roots that have an influence on the healthy growth of the tree: Efforts will be made to preserve said tree, including adjustments to facility design, based on the opinion of the tree doctor.
