Measures to Remediate the Vitality of Ginkgo Trees (Implemented April–June, 2024)

Tokyo, Japan, July 19, 2024 – The developers of the Jingu Gaien District Urban Redevelopment Project (hereinafter, "the project") today announced measures to remediate the vitality of ginkgo trees have been implemented with the goal of improving the growing environment for these trees.

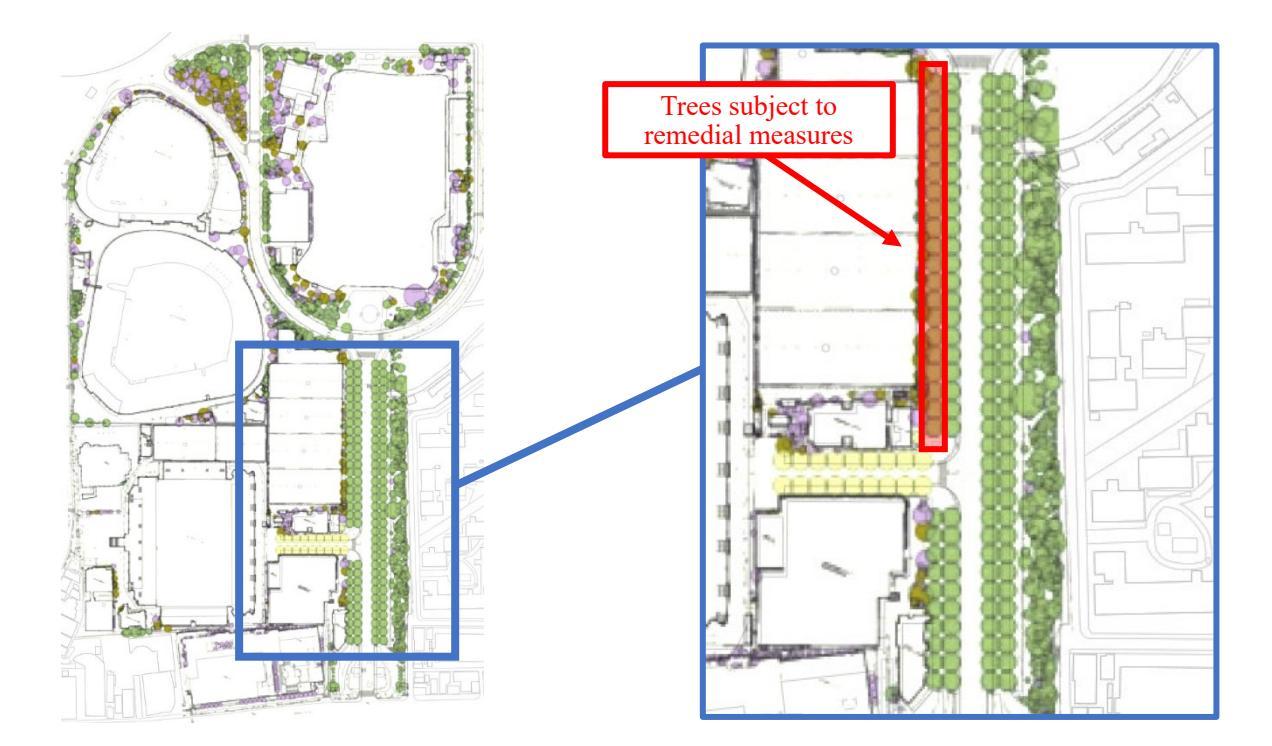
Since April 2024, we have been implementing six measures to remediate the ginkgo trees circled in red in the diagram below. Details of these measures are as follows.

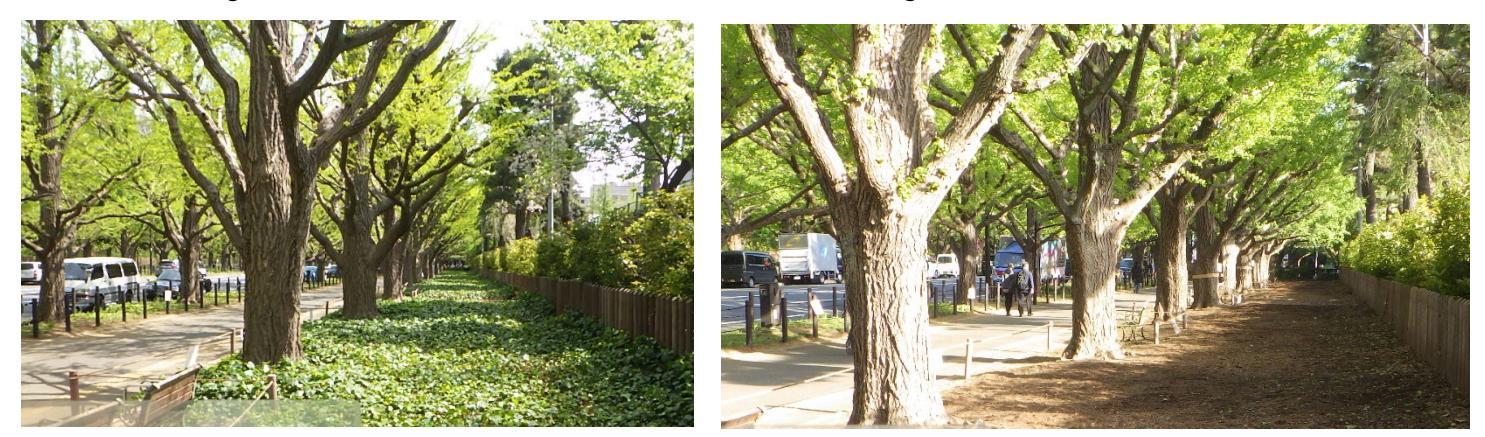
(1) Clearing of hedera and undergrowth

Over the upper layer of the ginkgo tree root system, there is an extremely vigorous growth of *hedera canariensis* ("hedera"). We thoroughly removed this layer of undergrowth, while taking care not to damage any roots, in order to remove the stress on the trees that comes from having to compete for water.

■Before clearing

■After clearing

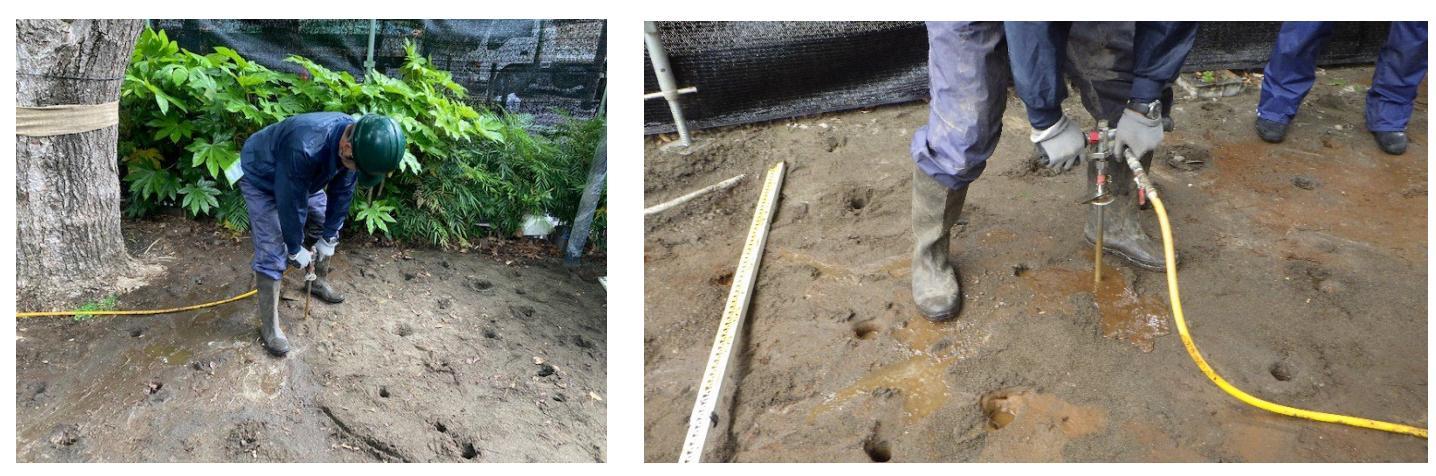
(2) Using water injection to improve soil

Soil survey results have indicated that some of the soil around the trees is in a compacted state. To mitigate this and realize an environment that makes it easier for the ginkgo tree roots to grow, we used water injection to soften the hardened areas, which improved soil quality while avoiding damage to the roots as much as possible.

■Water injection

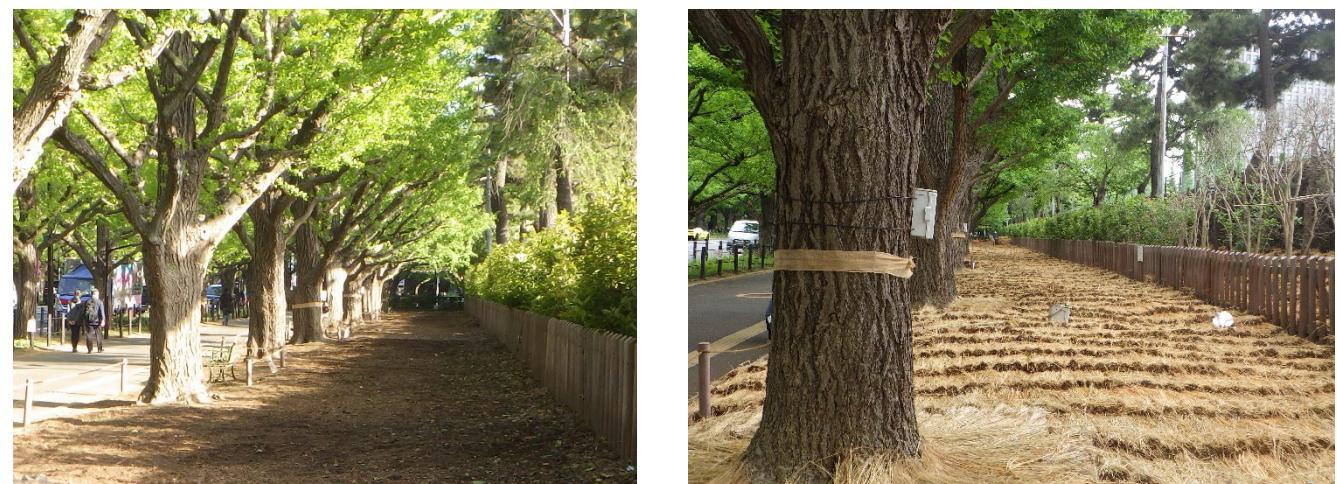
(3) Laying rice straw mulch

We laid a layer of rice straw mulch to prevent the soil from drying out, particularly in summer, and to keep it warm in fall and winter.

■Before mulching

■After mulching

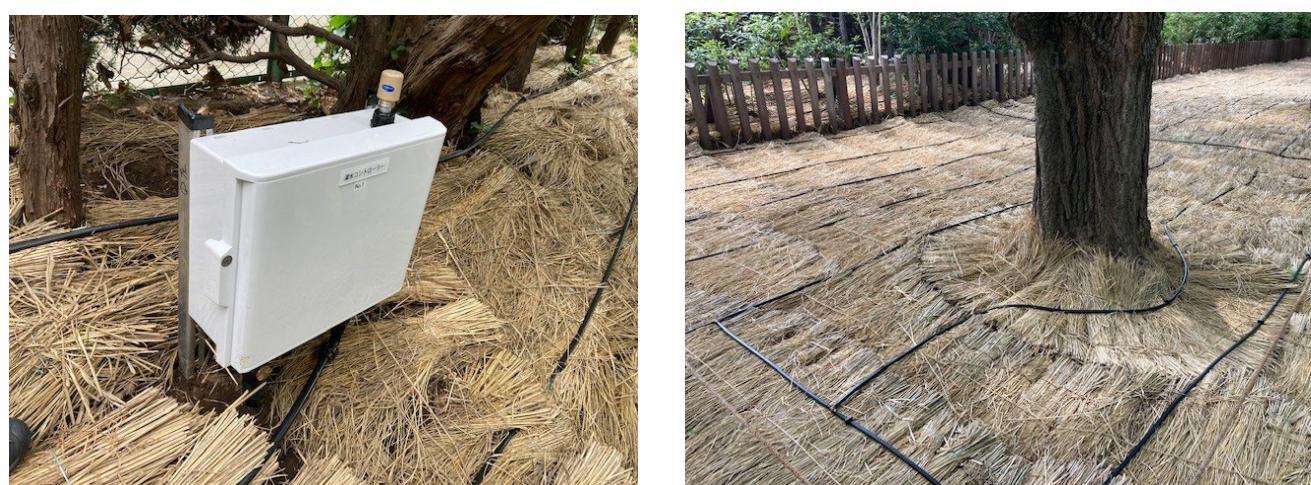
(4) Installing an irrigation system

We have installed an irrigation system that can provide regular watering automatically in order to ensure the ginkgo tree root system has sufficient water.

■Hose network

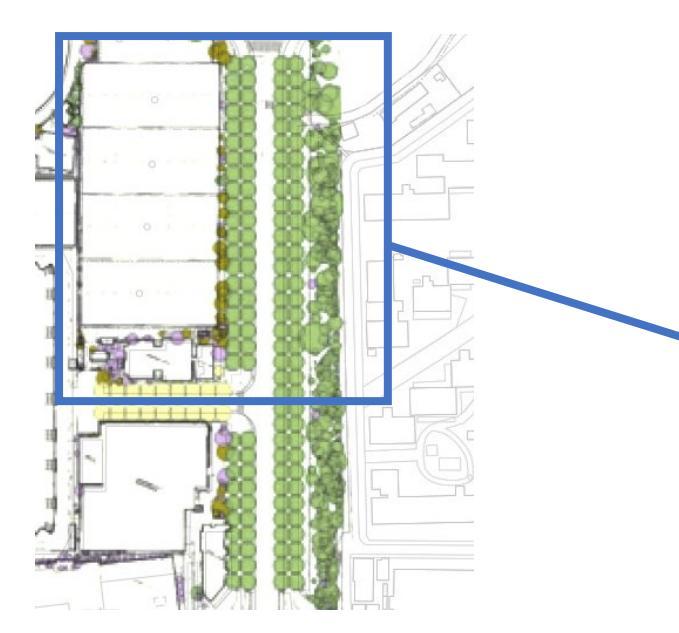
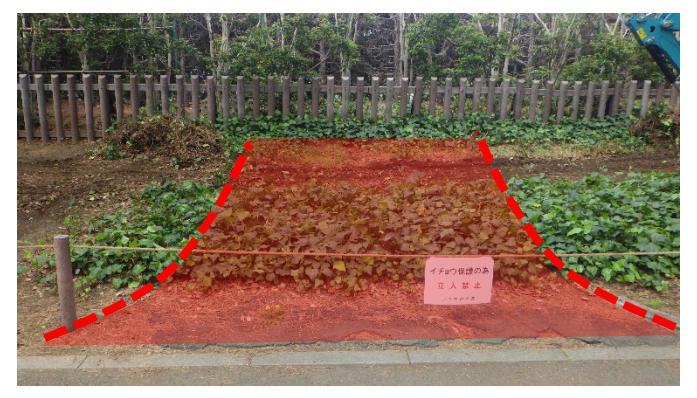
(5) Removing the roadbed of a former road

The roadbed of a former road, which was laid before the current tennis courts were constructed, divides and obstructs the growth of the root system. Therefore, we carefully removed it in a way that does not damage the ginkgo roots and replaced it with good quality soil.

Before work started

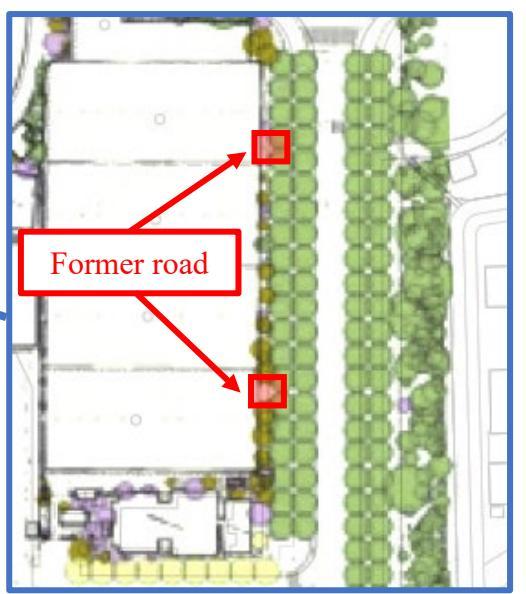
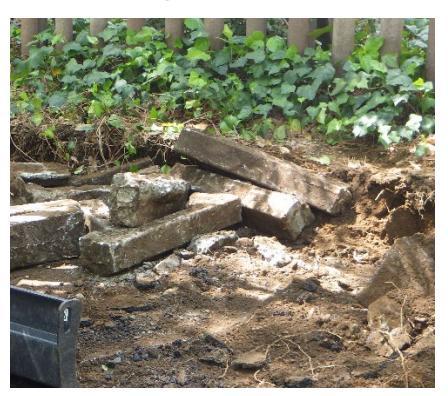
Dismantling the roadbed

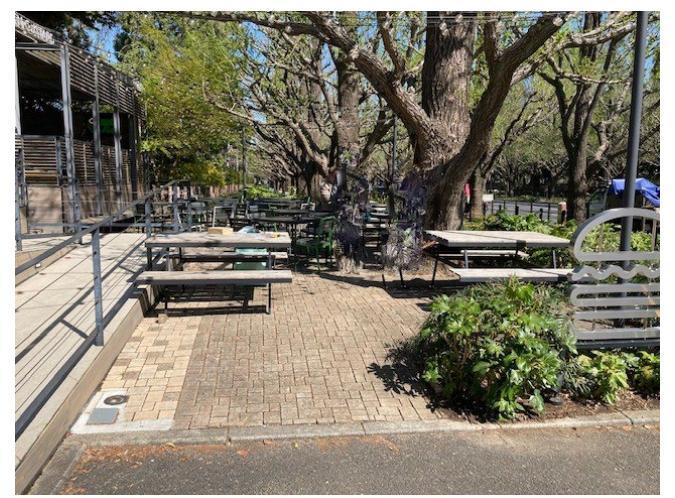
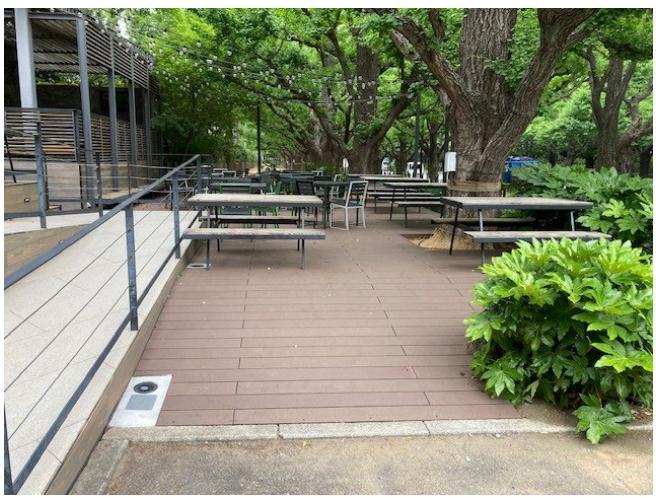
(6) Installing wood decking in the shops lining the road passing through the ginkgo tree rows

We removed the interlocking blocks used as flooring for the shop terraces and then carried out water injection to improve soil quality and realize a better environment for the ginkgo tree root system. To prevent it from drying out, we laid rice straw mulch and installed an irrigation system. Above this, we installed raised wooden decking as a way of avoiding stress on the root system from pedestrian foot pressure.

■Before installation

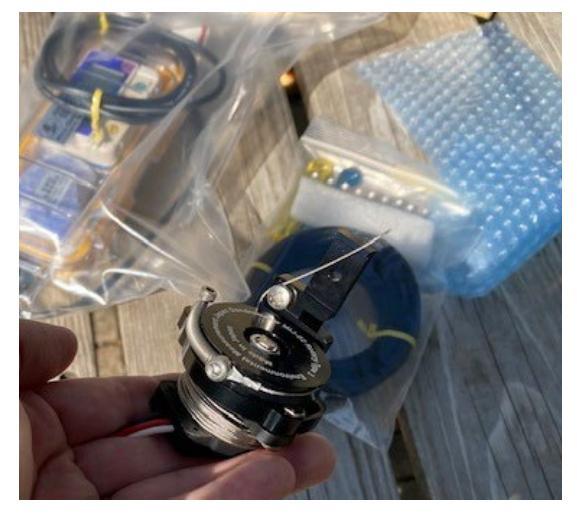
In April 2024, we installed dendrometers on eight of the ginkgo trees. Dendrometers are devices for measuring trunk circumference and as the condition of the tree is most noticeable in the trunk, dendrometers can be used to monitor the growth of the ginkgo trees and check if the remedial measures are having an effect. Installing dendrometers has no negative effects on the trees.

■A dendrometer

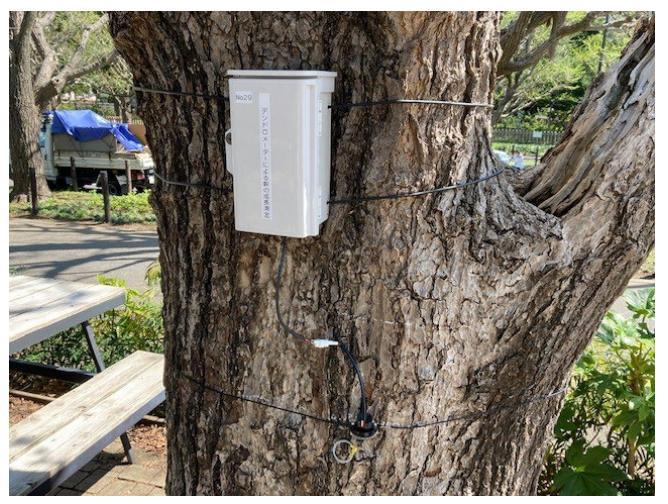
■After installation on one of the ginkgo trees

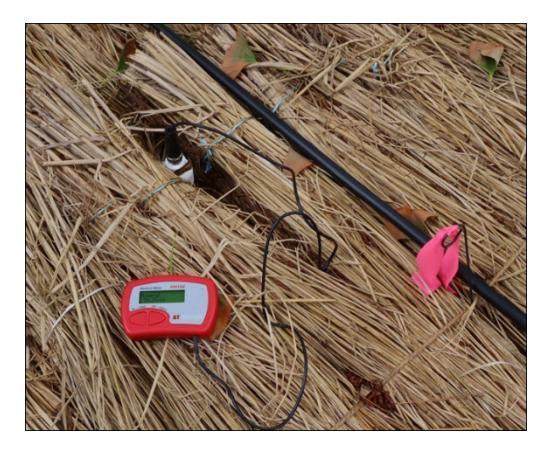
We are regularly measuring the moisture content of soil near the westernmost row of ginkgo trees. Through these measurements, we can monitor whether the soil is too wet, appropriately moist, or too dry, as well as whether the timing between watering and the amount of water being used is correct.

Measuring soil moisture content
